Axia Microphone Node

Update Instructions

INCLUDING VERSION NOTES

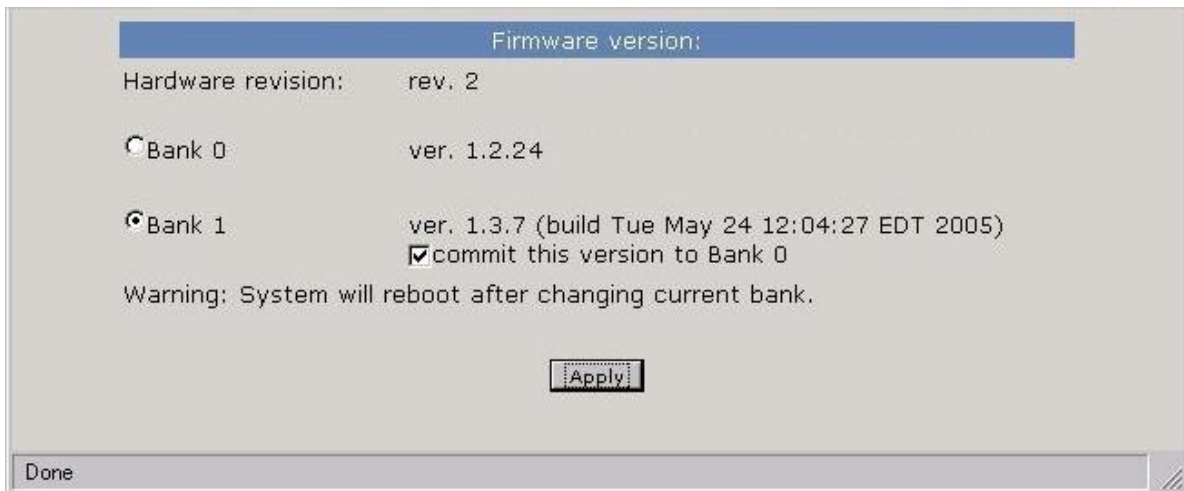
2. Open a web browser and connect to the node to be updated. Enter the complete path and file name for the software file (e.g. the file downloaded form the Axia site), or click on the *Browse* button to locate the file. Once the proper path and filename are displayed, click on *Apply* to download the file.

3. A successful download will be indicated by the new version being displayed in the *Bank 1* field. If the download is unsuccessful the field for *Bank 1* would be blank.

The software version in each bank is displayed from the System web page. The lower half of this screen, shown below, shows the current firmware versions and allows you to select what version will be used at startup. To change banks simply click in the “radio button” for the desired bank and then click on Apply.
